# **SYSTEM DEFECTS OF EXTERNAL CLADDINGS FOR RESIDENTIAL HOUSING IMPLEMENTED IN THE AREA AFFECTED BY INDUSTRIAL ACTIVITIES**

## **Summary**

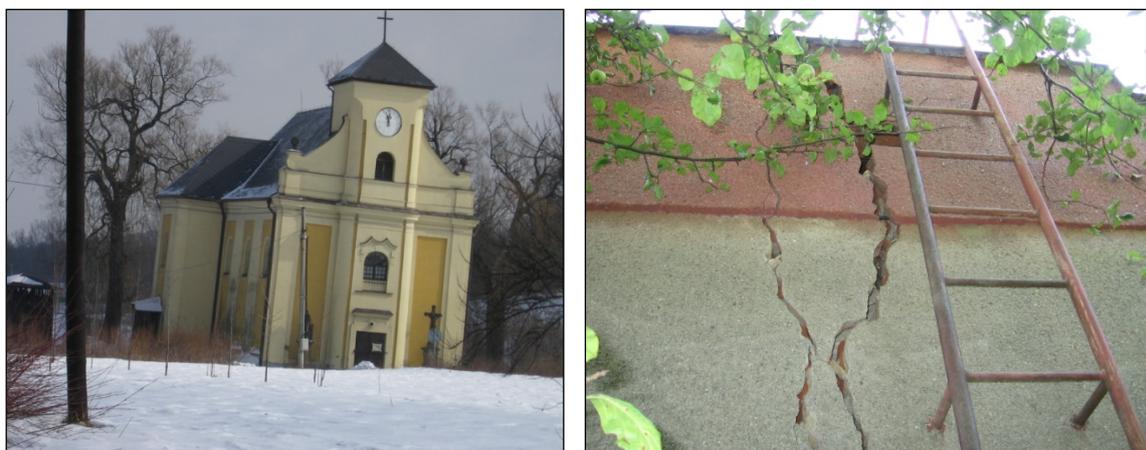
(**Fig.1**) shows some defects and failures resulting from the mine excavation: subsidence of a building and, in turn cracks. Such defects and failures occur in historic buildings, brick buildings and in buildings made from panel blocks.

*Fig. 1 Buildings influenced by undermining*

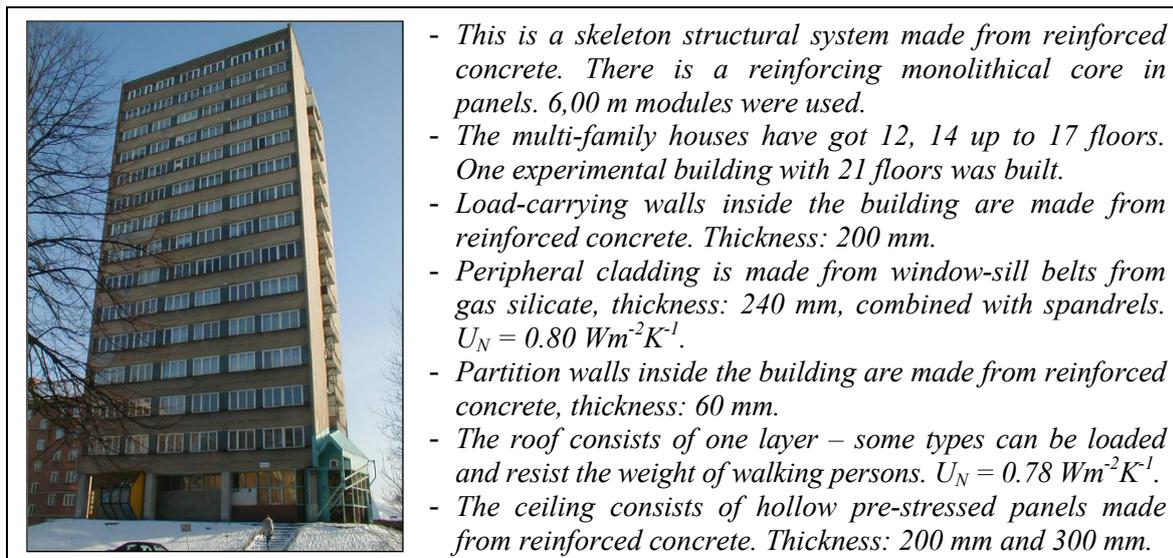
The monitoring has proved that the mining has not resulted in failures and defects, this means, the cracks, in T02B-OS, T03B-OS and BP-70-OS. Such as cracks have been, however present, in rather tall panel block buildings which were identified as the type ID VOS in the Ostrava and Karvina Regions. (Fig.4) shows basic parameters of those buildings. Regarding T02B-OS, T03B-OS and BP-70-OS, certain degradation has been witness on the peripheral cladding. In Orlova, joints in the peripheral cladding started degrading.

**Fig. 4** Parameters of a tall panel block building

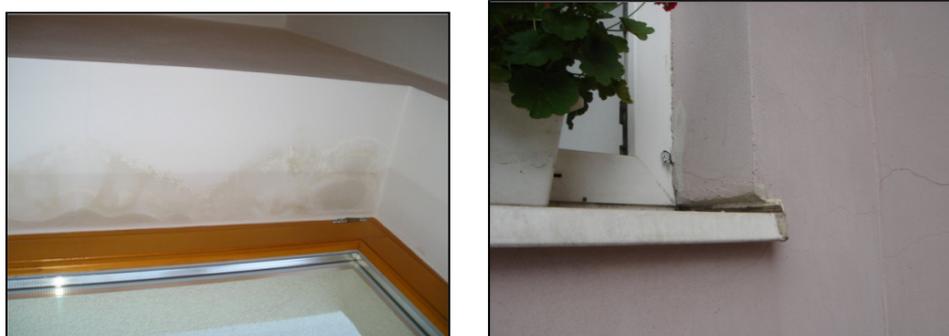
In spite of much progress and innovations in heat performance which have been reached in last decades, there are many critical details in peripheral cladding. (Fig.6) shows typical current defects and failures. Reasons include:

- Design of the critical details pursuant to ČSN 73 0540,
- Technologies and speed of construction.

*Fig. 6 Failures relating in the peripheral cladding (lintels above doors and windows).*

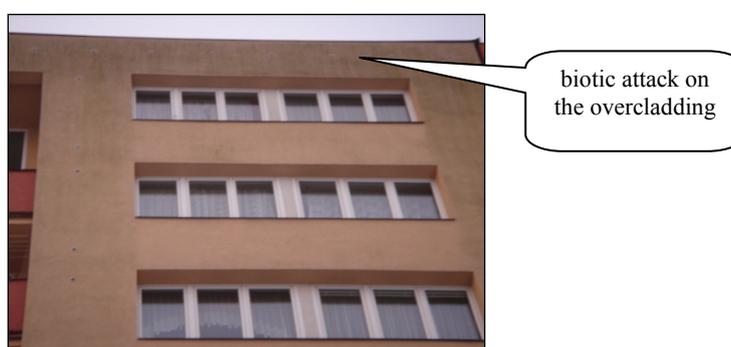
An example is a remediated panel-block building with apartments. See (**Fig.7**). The paint on the overcladded façade changes its colour – from the attic along the peripheral cladding to the bottom.

*Fig. 7 Overcladding of a panel-block multi-apartment building*

In case of the ETICS cladding of the panel block buildings, the defects and failures were consequence of technology issues – for instance, poor preparation of the substrate, poor construction discipline, failure to keep consistent components or underestimation of weather.

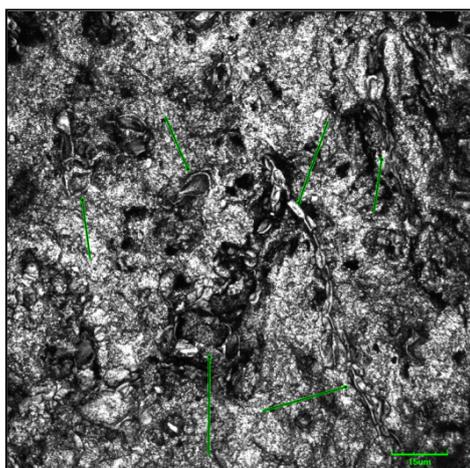
Biotic attack has been revealed in a sample of the overcladding. The samples were analysed in laboratories using a confocal microscope [11]. (**Fig.8**) shows photos taken in the confocal microscope – see cells and cell clusters (chains). A water extract of plaster samples was observed in a light steaming microscope. Microimages (**Fig.9**) prove growth of algae, fungi and cyanobacteria in the sample. *Chroococcidiopsis* sp. is the species of cyanobacteria. Green terrestrial algae (*Chlorophyceae*) are definitely present there. In some places, colonies occur in the sample. Considering the type of the sample, it was not however possible to identify a particular species. Fungus hyphae and spores were also witnessed in the sample. Because the sample was rather small, it was not possible to identify the type of fungus/mould. This has proved presence of living organisms (algae, cyanobacteria and fungi) in a sample of plaster.

**Fig. 8** Analysing the sample in a confocal microscope and algae in the sample

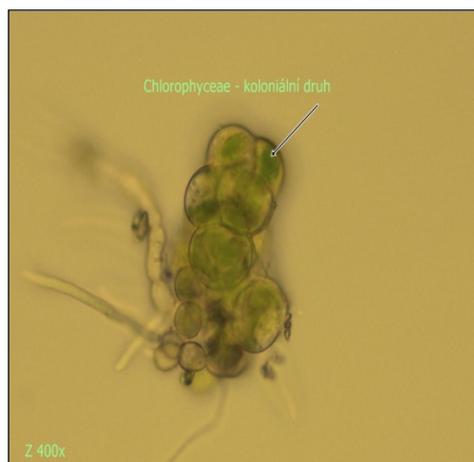
**Fig. 9** Presence of cyanobacteria, fungi

Occurrence of living organisms, moss and algae in peripheral overcladding is a rather pressing issue. R. Büchli and P. Raschle [12] mention that secondary effects of biotic attack on overcladded facades were not expected, the reason being phenomena typical of construction physics. Research and innovations are often based on traditional approaches to the building industry – this is a try and error method which has been used in past for other building elements and structures.
