## **RECONSTRUCTION OF PLEČNIK'S FOOTBRIDGE AT PRAGUE CASTLE**

### **Summary**

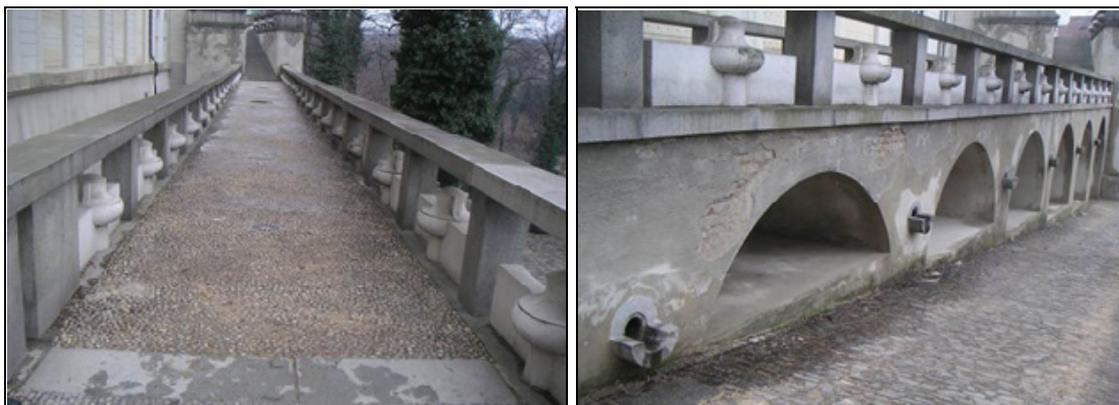
The sample of not sustainable way of reconstruction of small but important and significant structure of Plecnik's foot bridge located at Prague Castle area is discussed at this contribution. The structure was strongly impaired 10 years after complex reconstruction. This damage and degradation was caused mainly due to malfunctioning of new waterproofing and frozen water in the new drainage system of the bridge deck.

*Fig. 1, 2* Bad state of bridge 10 years after complex reconstruction during 1995–1996. Left, an overall view of the bridge deck in 2005. Right, a view of the arches towards Deer Ditch. There is seepage of water from the malfunctioning water insulation and damaged a broken gargoyle taking the water from the gullies in the bridge deck.

The joints of the hand-railing elements made of granite were sealed with silicone cement, and the balusters made from artificial stone received local repairs. However, the tightness of the bridge deck was subsequently damaged again. This was demonstrated mainly by infiltration of water into the bottom face of the arches, soaking and degradation of the plaster on the brick substructure, and leakage into the former substation. The bad condition of the bridge in 2005, about 10 years after the reconstruction, is shown in Fig. 1 and Fig. 2.

- optimize the drainage system for the surface of the bridge deck,
- execute functional, permanent, tight and reliable water insulation of the bridge deck,
- secure the sewerage system against freezing up,
- prevent water from the adjacent staircase getting on to the footbridge,
- modify the gargoyles and drip plates,
- repair the drainage of the north courtyard,
- reconstruct the brick substructure.

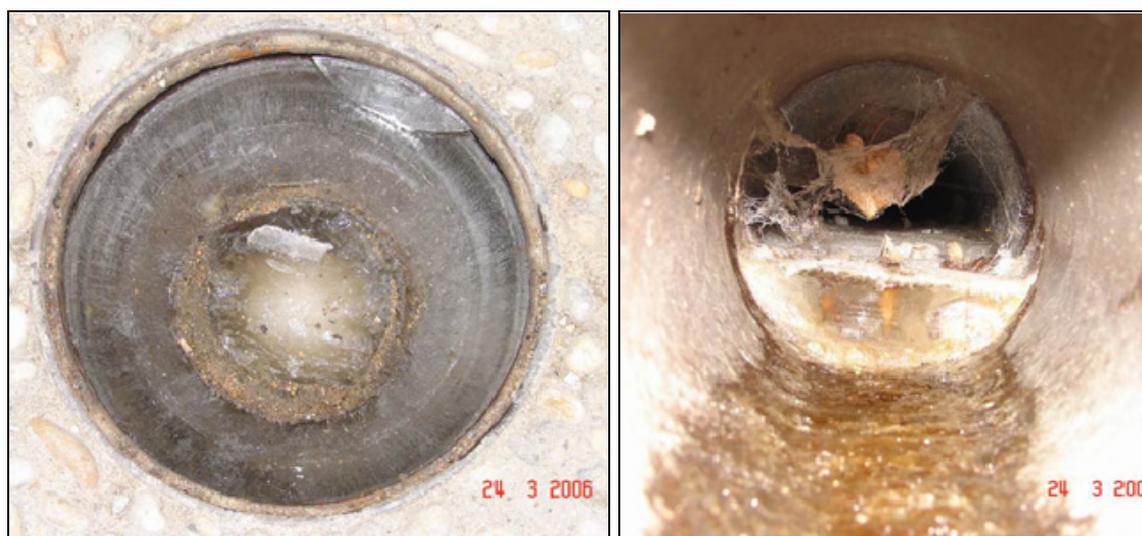
The diagnosis showed that the gargoyles freeze during the winter season, and slush and water from melting snow accumulate in this part of the footbridge. The freezing begins in the elbow-bend of the sewerage pipe, from where the ice plug grows in both directions (see Fig. 3, 4). The ice start to melt gradually later and a water column is formed on the upper side. This water then leaks through the untight joints of the sewerage back to the structure above the arches.

*Fig. 3,4 Left – view of a fully frozen inlet, right – view of a partially frozen pipe from the inlet to a gargoyle*

We designed additional two inlets on the lateral line of the footbridge, which had previously had no drainage of its own, and we proposed unifying its surface with the main line. This design was approved by the heritage protection authority. In order to prevent repeated freezing of the sewerage system, a system for heating the sewerage drainage leading from the inlets to the gargoyles was designed (see Fig. 3, 4).

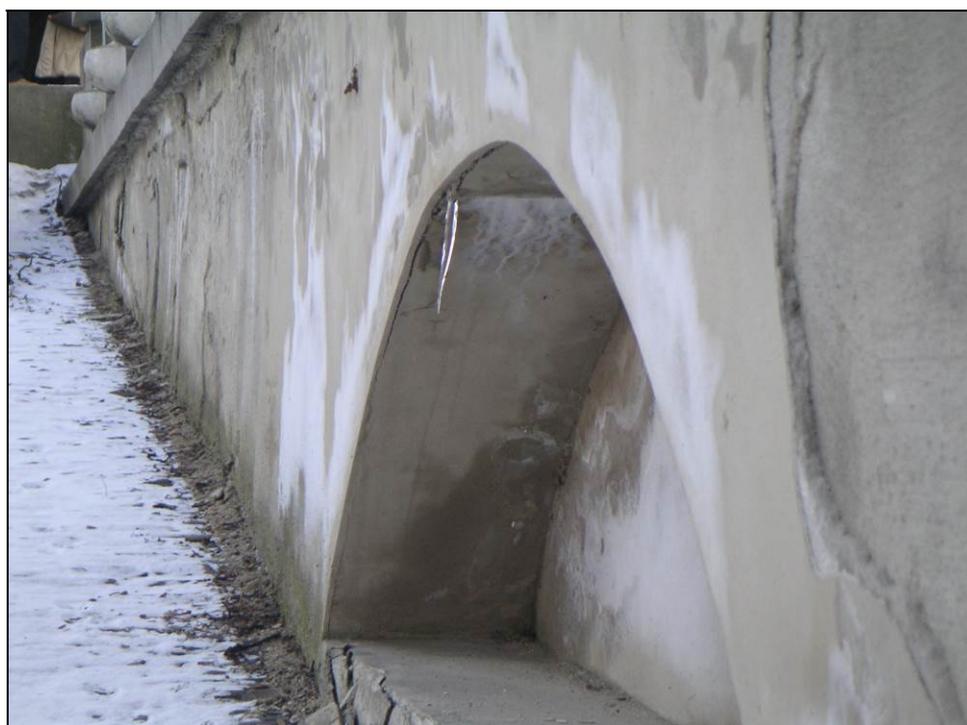
*Fig. 5 North side Plecnik's footbridge in spring 2006*

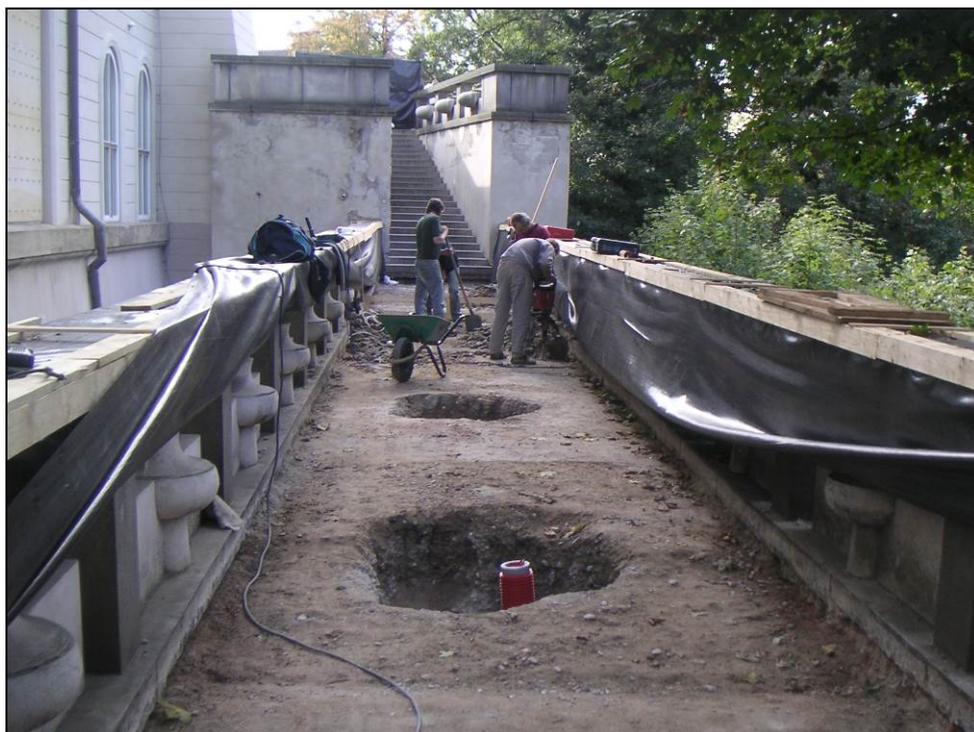
Beneath the paving, only thin layers of cement crust with numerous cracks were found. They were covering rough patchy concrete and the partly exposed brick masonry of the vault lines. These layers were also removed. The crowns of the vaults formed natural watersheds and the lean concrete among them was removed in a way that would allow the shape of the foundation beneath the new water insulation to be modified.

*Fig. 6 Demolition works on the bridge deck in autumn 2006*

It was also necessary to demolish the existing downcomers to the gargoyles up to the point where they bent (Fig. 6), in order to install new pipes in the original pipe with the heating system. After the new pipes had been installed, the heating cables and the thermal insulation of the vertical parts of the piping were mechanically protected and covered in concrete. The connection with the heating was set in the linear joint on the left side of the footbridge. After high-pressure water jetting, the foundation for the Bakor water-insulation screed was silica-fume modified concrete (Fig. 8). The water insulation was installed as a basin shape retracted under the edge of the handrail ledgers. First, the horizontal linear edge strip of Bakor 790-11 screed was applied with a polyester reinforcing insert. Then, area basin insulation was installed in a two-layer version with a reinforcing insert, leading out on the side of the linear stones up to a height of about 20mm below their upper edge. The installed insulation was covered with a layer of Bakor Globeglas No. 8 for the walking load (Fig. 9). During this phase, the drain plates were also prepared and were set in hot modified asphalt screed and covered with reinforced screed up to the edge of the vertical sewerage outlet. When this work was being done, the option of a natural outlet for water from the whole area of the insulated surface was carefully considered.

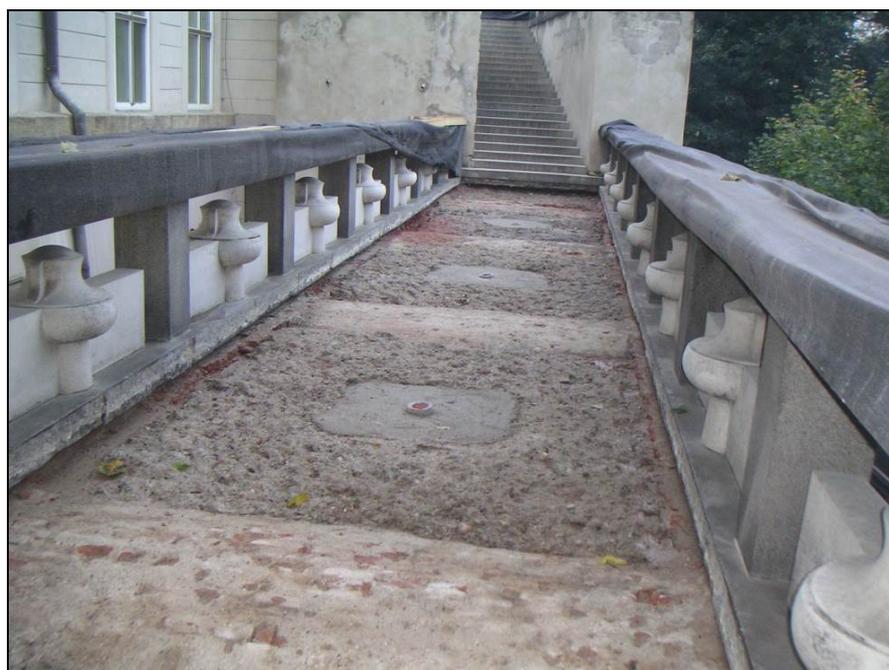
*Fig. 7 Substrate prepared by high pressure water before the electric cables were installed and the surface was restored*

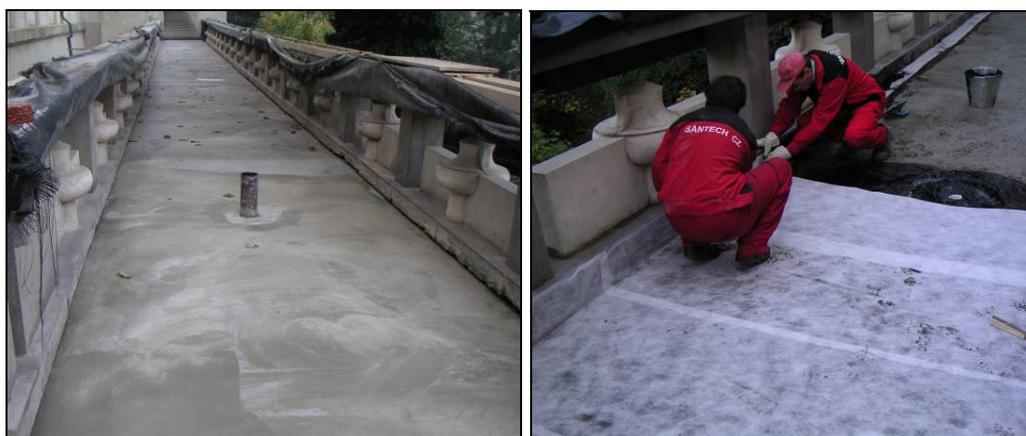
*Fig. 8, 9 Left – view of the new substrate for water insulation, right – working on the first layer and details of the BAKOR water insulation system*

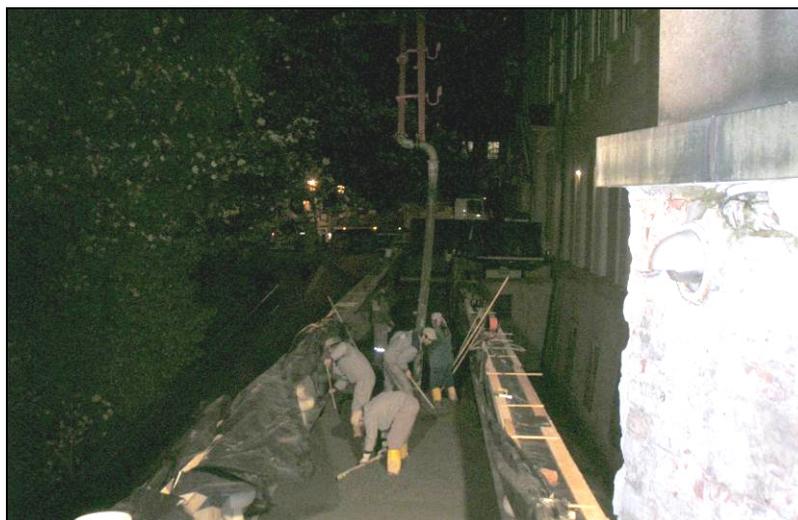
*Fig. 10* Concreting of final bridge decks that covers water proofing layer

After the insulation had been installed, work began on the new modified concrete reinforced slab (Fig. 10). First the steel welded mesh reinforcement was laid and bound, and then the slab was concreted. The concreting was done at night, in order not to disrupt the operation of the Castle. At 8 p.m., a mobile pump with a 46 m arm arrived. Directly in the concrete plant, the finished concrete mixture was supplemented with Ad-Mix 50 modification additives based on micro-silica. This could be done because of the short transportation time. Re-milling on site was therefore not necessary. Fresh concrete mixture set by pumps was spread on the site, compacted and manually arranged into the gradients needed for each drainage area with diagonal neck gutters. The surface was smoothed manually and was jetted with a curing agent against excessive water evaporation. On the next day, lateral contraction cuts were made on the watersheds, and the bridge deck was protected against night frosts.

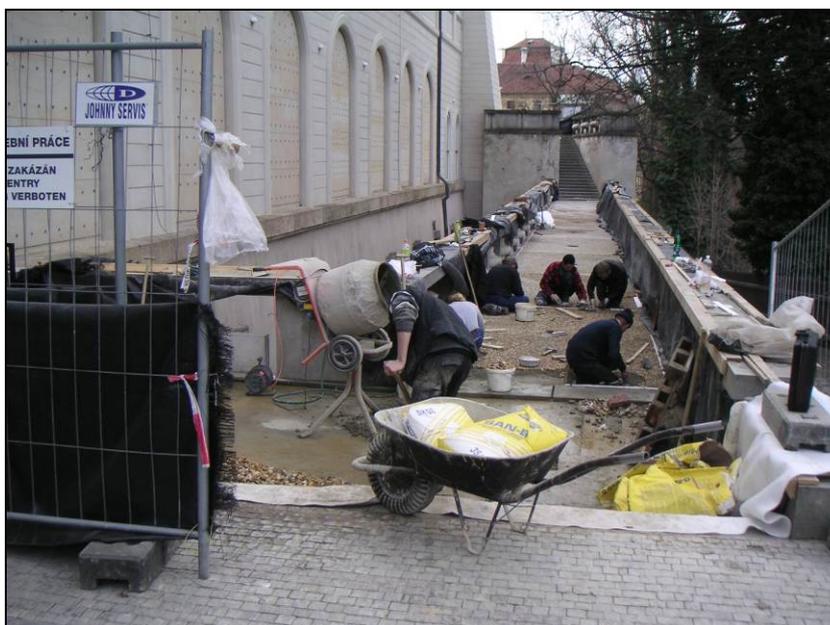
*Fig. 11* Working on the new cobblestone paving, laid on top of the new modify concrete slab, situation in November 2006

After about one week of maturing, the weather improved and it was possible to start with the cobblestone paving (Fig. 11). The pavement with selected and washed cobblestones was first laid as a sample, and after approval it was fully placed. The cobbles were first placed into SAN B B30 micro-concrete using a tile laying technology, and were finally sealed with special SAN B R2 modified mortar polymers (Premix Ltd.). The linear joints along the hand-railing, and around the bottom part of drains remained loose during this work with the use of a polystyrene insert. After the paving was finished, the joints were cleaned and filled with Bakor 590-13 modified asphalt sealing compound. In order to reduce the colour contrast, the warm compound was cover up with dry silica sand. The existing concrete pavement in the north courtyard (Fig. 12) was demolished, and its bed was removed.

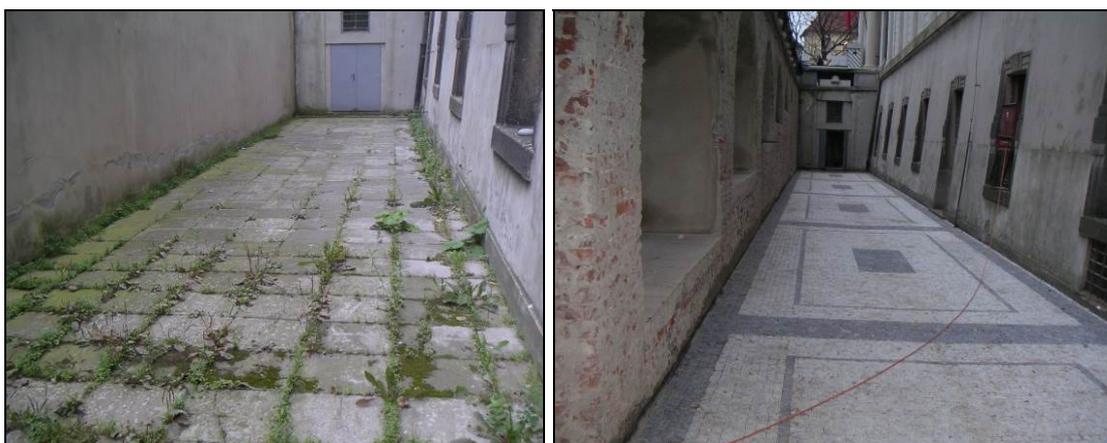
*Fig. 12, 13 Left view of the north courtyard, before restoration. Right – after restoration*

The foundation was cleaned down to the protective water insulation geotextile of the heating channel leading under the whole courtyard. At the same time, the original lateral drainage gutter in front of the entry to the substation was demolished. The original gutter had no bottom, and was not fitted with inlets on the insulation level. The new gutter was provided with inlet openings from the courtyard and door side. The existing insulation was completed from both sides with a new strip of elevated mortar fillet, and the shape of the surface of the courtyard was modified into a bilateral gradient with a linear neck gutter in the middle. The upper area of the gutter with cast iron grids was also shaped in a similar manner. The paving was done with black and white segmentation, on the basis of preserved sketches by Josip Plecnik, attempting to keep the proportions in relation to the dimensions of the area (Fig. 13).

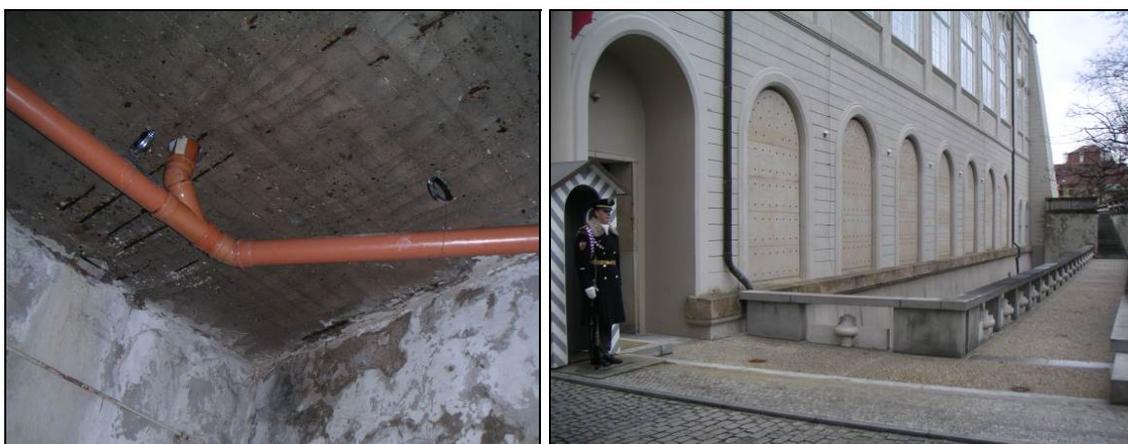
*Fig. 14, 15: Left – ceiling surface prepared by high-pressure water, new plastic pipes for draining a small part of Plecnik's footbridge, right – the footbridge after restoration*

The last part of the reconstruction involved renovating the suspended ceiling of the reinforced ceiling of the former substation, below part of the lateral line (Fig. 14). The renovation was made in a standard manner: demolition, high-pressure water jetting, passivation of further corrosion of the exposed steel reinforcement, local coarse reshaping, fine screed over the area, and protective cement modified paint (SAN B system, produced by Premix Ltd.)
