CHANGE AND CONTINUITY IN TRADITIONAL ENVIRONMENTS: CASE OF GÜZELYURT (GELVERI-KALVARI) - TURKEY

Ümmügülsüm Ter

Elmas Erdoğan

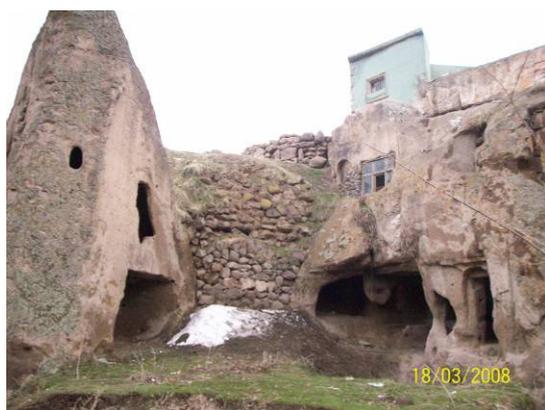
Fig. 6 Rock-carved houses

Rock-carved houses: Rock-carved houses, mostly located in the lower neighborhood, have an organic planning scheme formed from carving square or rectangular spaces in accordance with the need. There are spaces such as toilet, storehouse and stable built in a masonry system in the courtyards bordered with rubble walls. This distinctive texture flourishing with rock-carved streets, stairs, chapels and shelters made up the traditional settlement texture of Gelveri until the 19th century (**Fig. 6**).

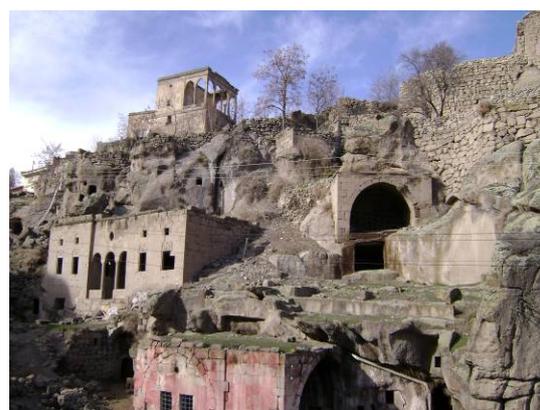
Fig. 7 Rock-carved + masonry houses

Rock-carved + masonry houses: Most of these kinds of houses, located on the slope, are units having a front entrance with masonry system annex. In some houses it was made up of one volume opening to an external anteroom with colonnade accessed by stairs from the courtyard. There are also very special units called "hospitality room" thanks to the stone ornaments in the exterior front, wooden cupboards and ceiling ornaments within the space. These allow for actions such as eating, sitting and sleeping. Houses with their front towards the road and whose outbuildings overflow to the road attract attention both from the courtyard and the street thanks to their monumental structure. In these kinds of buildings, the ground floor is in the form of rock-carved units. These units are generally used as service spaces such as kitchen, storeroom, hayloft and stable. Masonry units are used as life spaces. The main fronts of masonry units facing towards the landscape were made from cut-stone, and they are mostly ornamental (**Fig. 7**).

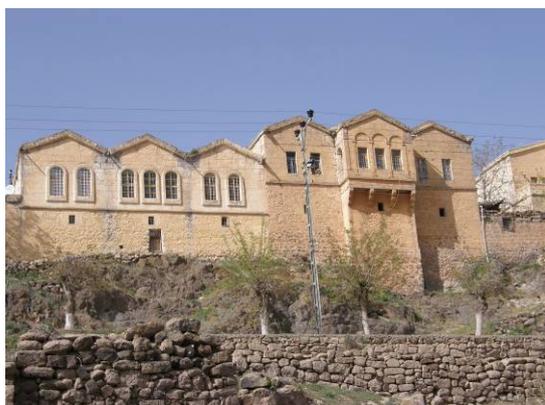
Fig. 8 Masonry houses

Masonry houses: This is the last ring of housing typology development in the region. They were planned on road fronts of the courtyards in different sizes and order in accordance with household needs. There are living rooms, tandoori huts and kitchens on the ground floors two-storey houses having iwans. Upper floors are made up of bedrooms and anteroom. Annexes such as hayloft, stable and toilet are located as masonry or carved units in courtyards of the houses (Fig. 8-9).

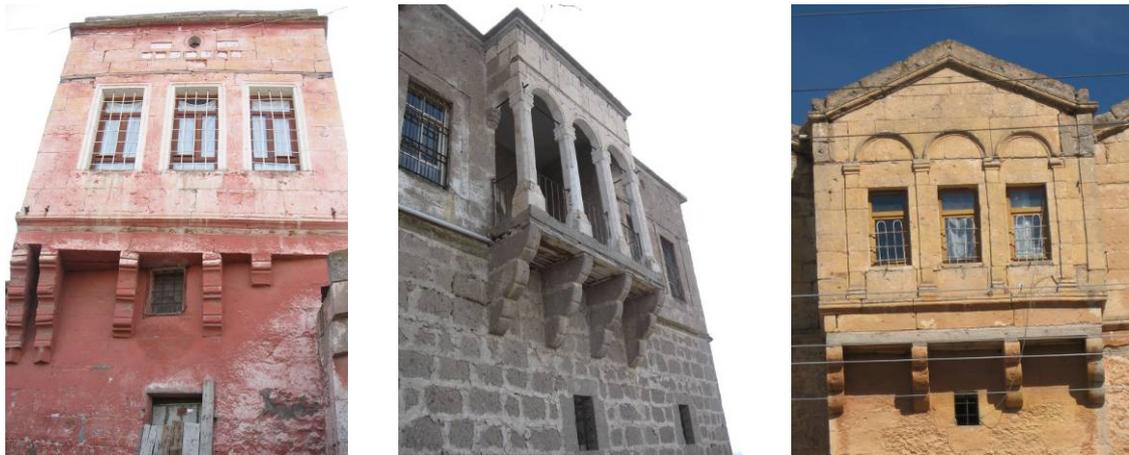
Fig. 10 Front elements of Gelveri houses

Stone is the main construction material of Gelveri houses. While delicate manipulation of the stone obtained from tuff quarries is conducted during the construction, remaining pieces are used in garden walls. While the connection of houses to the street was ensured through the garden wall and door sometimes, it was ensured via the traditional house front extending towards the street in other examples. Front elements make up the most decisive element of Gelveri houses' distinctive texture. On the second floors of the houses, outbuildings varying between 15 and 20 cm. from ground floor walls with two or three rows of stone brackets extend towards the street. There are geometric ornaments between cantilever stones [6](Fig. 10).

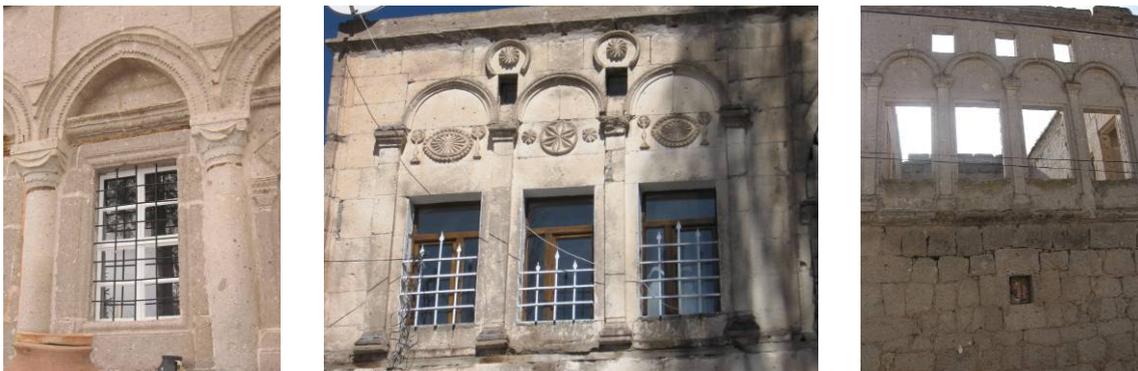
Fig. 11 Proportion and ornaments of the windows

One of the other most important components of Gelveri houses is the windows. Windows are generally simple. However, they are placed on the front by considering certain proportions. There are ornaments over the windows in some houses (**Fig. 11**).

Window openings and sizes went through changes in the course of time as a result of interventions in the houses. Narrow windows were enlarged with large windows, and balconies were annexed. Window frames were changed with PVC. Characteristics of the door deteriorated as a result of poor maintenance in the following periods, and just the lintels of some of them survived intact until the present time. Without taking the flow of flat roofs into consideration, they were changed with Marseilles tile, concrete or corrugated iron roofs. Materials such as briquette and brick that does not match with the quality of the area were used in repairs and annexes [6]. New houses were built over the old walls of buildings destroyed completely or partly in the traditional texture. Buildings were divided physically and proprietarily due to reasons such as legacy, and lost their original scheme.

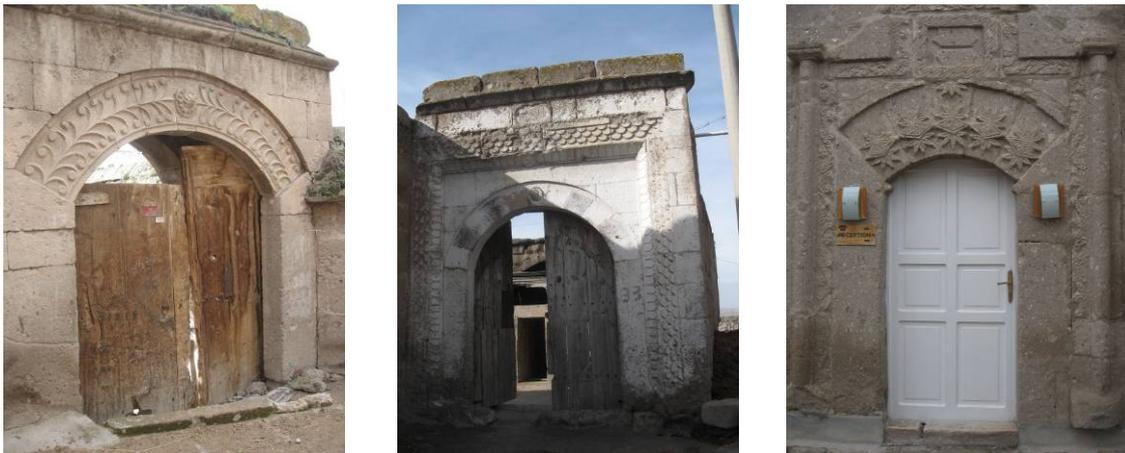
Fig. 12 Street doors of courtyards

Doors opening to the street in courtyard houses bear monumental values. These doors are larger compared to the house doors that open directly onto the street. Street doors of courtyards and houses are generally constructed as wooden wings. While big courtyard doors have two wings, smaller ones have just one wing (**Fig. 12**).

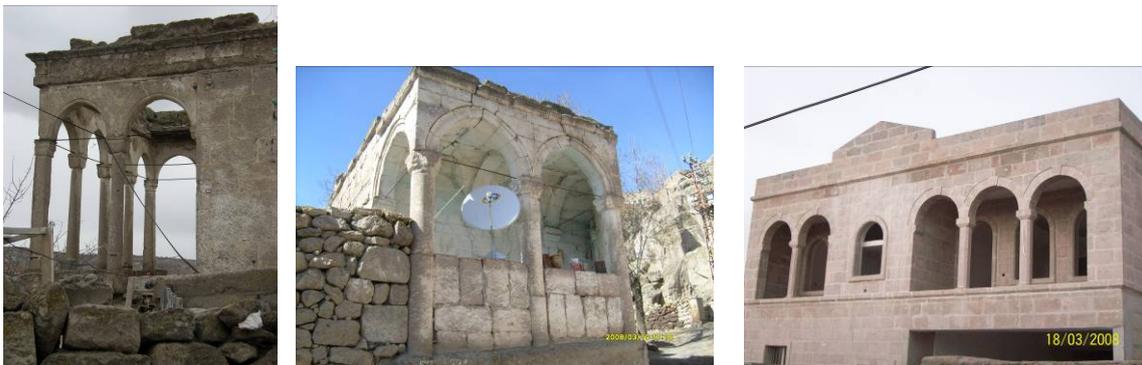
Fig. 13 Balconies samples of Gelveri houses

Balcony or summer openings face the courtyard or street. These openings, located in upper floors, open towards the street or inside of the courtyard via two or three arches. Generally, a single depressed arch order is used in arrangements. Arches are located on columns with circular sections. Geometric and vegetable ornaments with half circular sections appear over the arch stones. Roofs are generally plain and of packed soil [6] (**Fig. 13**).

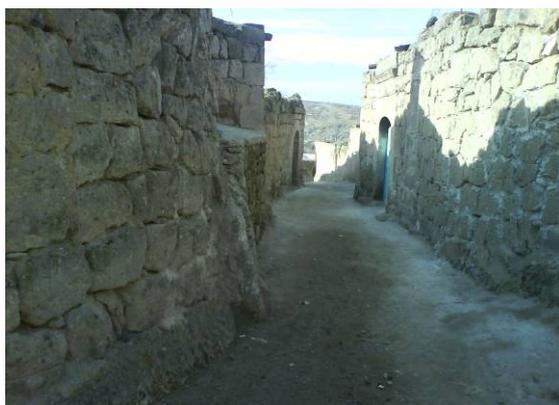
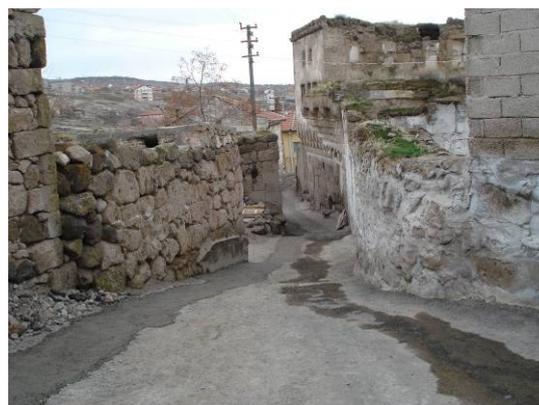
With the exception of newly opened roads, streets shaping the traditional texture are just large enough to allow pedestrian transition; and they were formed through carving the rock. We observe that streets reaching social, administrative and commercial buildings vary in terms of quality, though not in size, and are gradated among themselves [1][5]. High garden walls and fronts of the buildings came to be components setting boundaries for the street (**Fig. 14-15**).

Fig. 14 Akropol Street

Fig. 15 Meneviş Street

In traditional texture, uncontrolled interventions such as enlargement of the streets, turning the areas where destroyed buildings are located into green texture, constructing disharmonious buildings in addition to the original buildings, disregard of texture in new constructions, disassembling traditional street paving, and covering the roads with concrete parquet and asphalt led to the loss of texture integrity.
