THE USE OF BOARDS FROM RECYCLED LAMINATED CARTONS IN THE BUILDING ENVELOPE

Summary

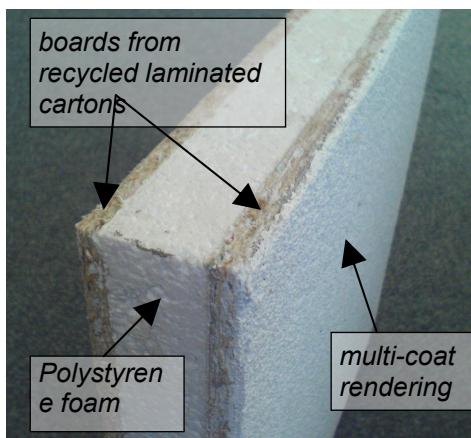
Fig. 1 Cutting edge of sandwich facade panel test sample with exterior rendering

panels (**Fig. 1**) are produced from these boards. There is a good practice with all the interior applications in dry environment but there is a lack of experience with the applications in humid interior environment, e.g. in bathrooms and in exterior. That was the motivation for the long-term durability test in real exterior conditions. Concerning the raw material both laminated cartons from sorted municipal waste and process scrap from the production of beverage cartons are used. The cartons are shredded (cartons from municipal waste are subsequently washed and dried), spread into sheets and compressed at a temperature of about 170 °C. The polyethylene (PE) content in the material melts and acts as a binder. Besides PE content in the raw material additional waste PE is being added to the raw material to reach the proper cohesion. Usual composition of the beverage cartons is as follows: cartoon ~73 %, PE ~21 %, aluminium ~5 %, pigments ~0.5 % (by weight). This kind of laminated cartons recycling seems to be the most efficient way [1].

Typical composition of the facade panels is as follows (from the exterior):

- multi-coat rendering: finishing coat – decorative finish / facade paint, base coat with reinforcement, bonding primer;
- facade panel: (i) recycled board: covering carton laminated with melted PE foil, board core from shredded recycled laminated cartons, bottom covering paper; (ii) polystyrene foam board EPS 100S; (iii) recycled board see above.

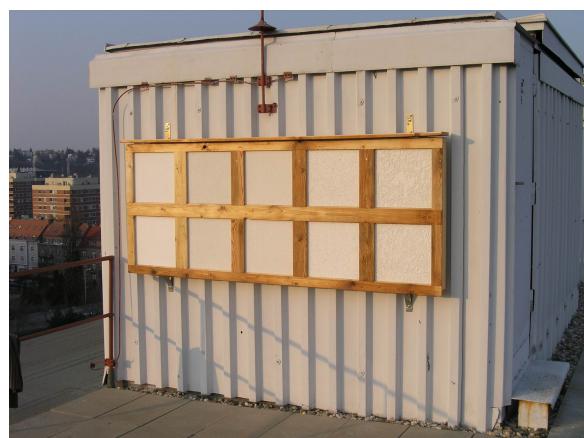
Fig. 2 Fixing frame for the durability testing of the facade panel samples

During the March 2007, a long-term durability test of the sandwich facade panels was launched. Altogether 15 panel samples with 5 different kinds of thin exterior rendering were prepared for the testing. Five samples (reference set) were stored in dry interior environment. Ten samples (exposed set 1, resp. 2 for 27, resp. 43 months) were placed in vertically fixed timber frame (**Fig. 2**), where the samples were fixed and sealed so that only plastered surface is exposed to exterior conditions. Completed assembly was placed on the roof of the Faculty of Civil Engineering at the Czech Technical University in Prague facing southwest where extreme insolation and driven rainfall can be expected. There was launched a surface temperature measurement on the panels and relative humidity measurement in the fixing frame behind the panels.

Except this measurement there were measured and logged external climatic data by a meteorological unit placed near by the fixing frame. The degradation state was regularly documented by a series of photographs. Throughout the test there were no visible marks of degradation like cracks or swelling, except the slight colour-tone changes of different panel samples.

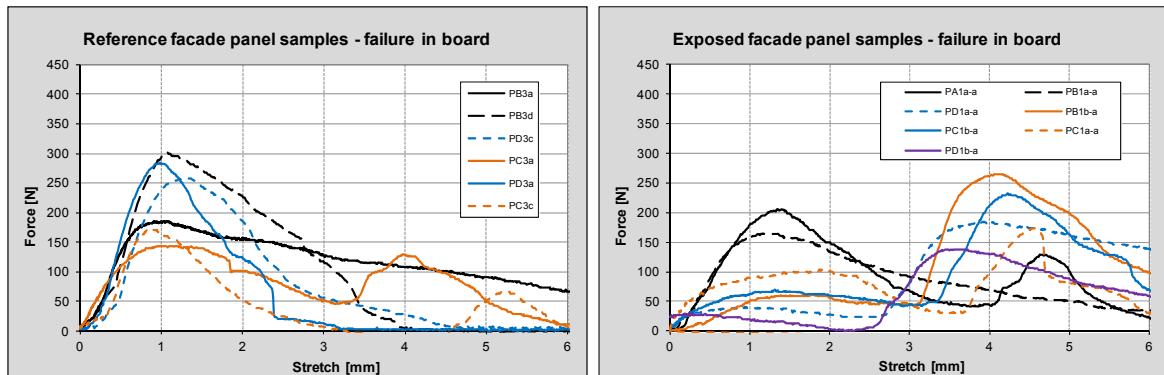
Fig. 3 Bond strength test deformation graph
 _ reference set with failure in the board

Fig. 4 Bond strength test deformation graph
 _ exposed set 1 with failure in the board

The graph (**Fig. 3**) shows the deformation of reference set of samples with failure in the board. The deformation graphs are characteristic with a fast increase of the force and a slow force decrease after reaching the maximum. The other graph (**Fig. 4**) shows the typical deformation graphs of exposed set 1 of samples with failure in the board. The mean bond strength by the failure in the board decreased after 27 months (exposed set 1) from 107 kPa to 90 kPa (84 %) and after 43 months (exposed set 2) to 87 kPa (82 %) [3]. Besides it is necessary to take into account the progress of deformation during the loading where the maximum strength is often reached at hardly acceptable deformation. Also the deviation of measured strengths is high, appreciable number of strengths didn't reach even 50 kPa.

The different character of deformation behaviour of the exposed set is largely caused by a progressive degradation of the material. The cyclic thermal and moisture load causes a progressive loss of bond strength of the covering carton and laminated carton inside the board. This progressive loss practically results in a very slow increase of the force in deformation graph (**Fig. 4**) when the maximum is reached at an extreme deformation. All this can result in fatal consequences. There can e.g. appear cracks in the rendering especially on edges of the boards and come to flaking off the rendering (pillow effect). This leads to an increased moisture content in the board and consequently to swelling and rapid loss of bond strength. The described degradation can arise not only during exterior climatic load but to smaller extent also in wet interior environment, e.g. in bathrooms.

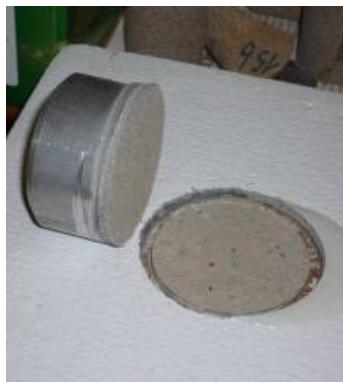
Fig. 5 Failures in the board:
in covering carton layer

The most typical failure occurred during the bond strength test was a failure in recycled boards. This occurred in all 3 layers of the board, respectively on interfaces between them, separately or in a combination (**Fig. 5 to 7**):

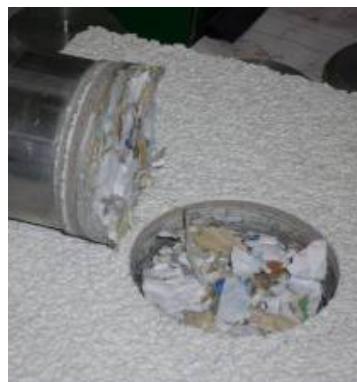
Fig. 6 Failures in the
board: in board core

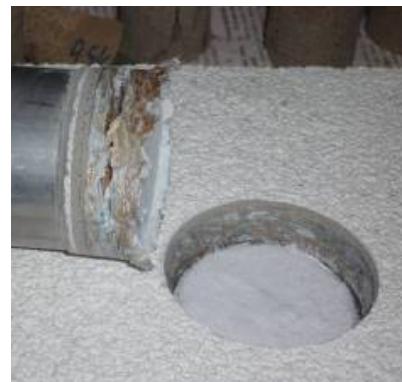
Fig. 7 Failures in the board:
in bottom covering paper.
