# ASSESSMENT AND REHABILITATION OF EXISTING BRIDGES

## Summary

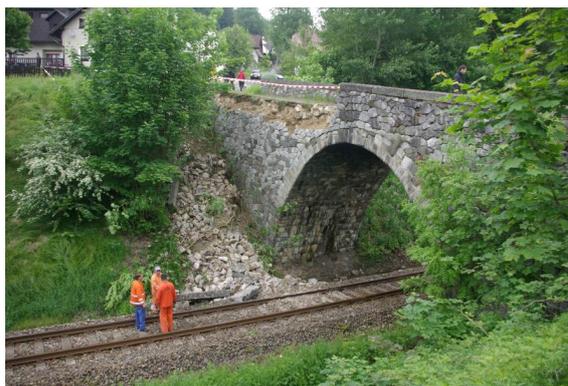
Shortly after the regular inspection of the bridge, its stone railing was accidentally impacted by a lorry with failed breaks (Fig. 2). About half of a stone railing and part of a breast wall fell down on a railway and the lorry finally crashed into a nearby dwelling house (fortunately with a minor injury of a driver only).

*Fig. 2 Damaged road stone bridge*

For assurance of further bridge serviceability, it could be sufficient to repair the damaged stone railing, to provide a new road pavement with insulation against moisture, to clean plants and grout mortar in masonry.

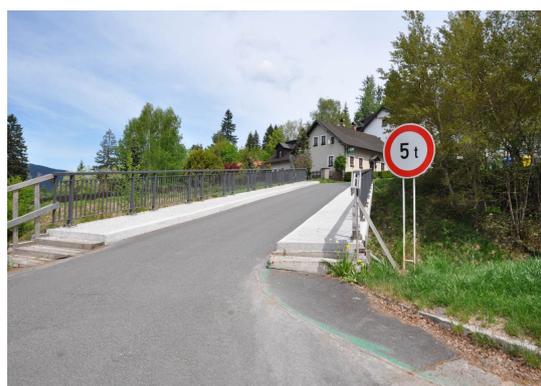
*Fig. 3 Rehabilitated bridge*

Finally it was decided to make a complex rehabilitation of a bridge where the total costs achieved 465.600 EUR. A heavy reinforced concrete deck was built, the masonry arch was tied and masonry grouted. New steel railing was installed on bridge which together with the heavy concrete deck adversely changed the original historic character of the stone bridge near the centre of the town. Despite of the complex rehabilitation, the bridge load bearing capacity of 5 t remained surprisingly unchanged (Fig. 3).

The stone arch bridge was superficially inspected only after the collision. Shortly after the accident an excessive rehabilitation of the bridge was proposed and executed. Application of a new reinforced concrete deck and steel railings unsuitably influenced the original historic character of the bridge. Moreover, the expensive rehabilitation did not lead to the enhancement of the low bridge bearing capacity of 5 t.
