# **SYSTEM DEFECTS OF EXTERNAL CLADDINGS FOR RESIDENTIAL HOUSING IMPLEMENTED IN THE AREA AFFECTED BY INDUSTRIAL ACTIVITIES**

## **Summary**

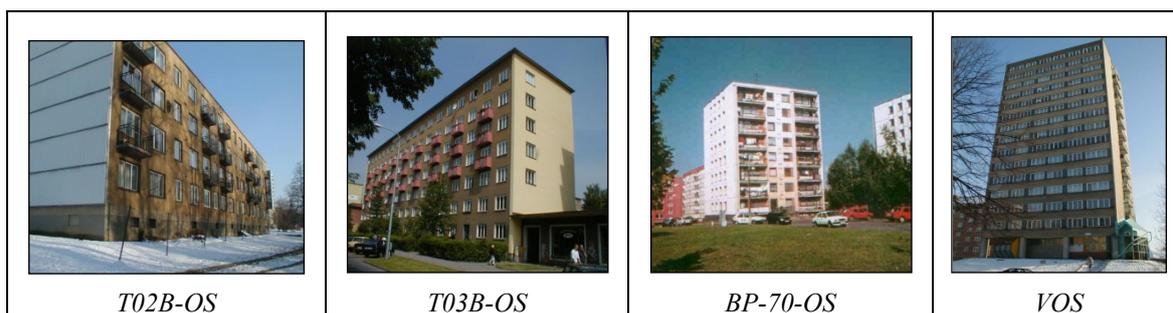
**Fig. 2** Types of apartment houses built from panel blocks – monitoring from 2004 to 2010

(**Fig.2**) shows the panel block buildings, while the chart in (**Fig.3**) shows parameters and numbers of the panel block buildings. Systemic failures and defects in peripheral cladding have been identified on the basis of the monitoring. The buildings included those built in the second half of the 20<sup>th</sup> century as well new buildings which have been built since 2004.

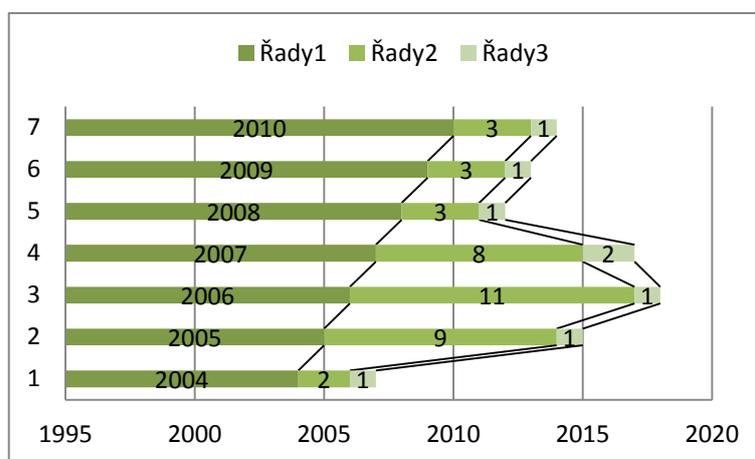
**Fig. 3** Number of apartment houses built from panel blocks – monitoring from 2004 to 2010

Comments: Line 1: period under monitoring;  
 Line 2: number of panel block buildings which have been monitored;  
 Line 3: the number of new buildings made from panel blocks

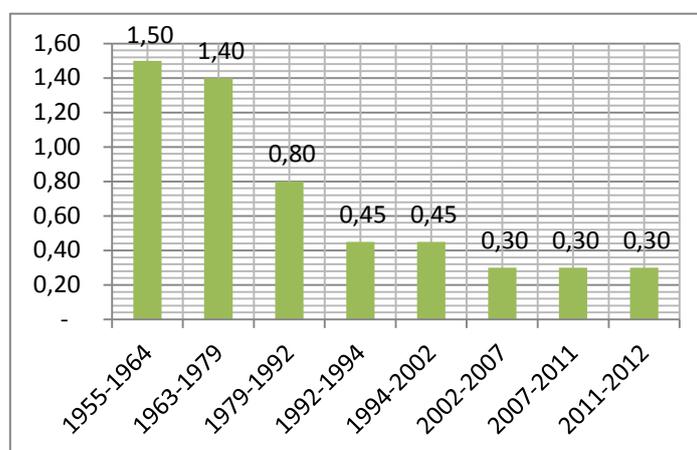
*Fig. 5 Development of the heat transmission coefficient in the peripheral cladding from 1955 to 2012 pursuant to ČSN 73 0540*

Some heat and moisture defects which were revealed in the panel block buildings resulted from lack of verified experience in designing of panel block buildings in the second half of the 20<sup>th</sup> century, development of ČSN 73 0540 [7] and even more stringent standards. Originally, the standards for the heat insulation of claddings were derived from masonry walls lined with kiln bricks with the thickness of 450 mm. Those standards have become more restrictive in the course of time. (Fig.5) shows development of a heat transmission coefficient for peripheral claddings  $U_N$  [W/(m<sup>2</sup>.K)] from 1955 to 2012. The reason for strict energy and heat performance has been the growth of energy prices and pressure of the company to decrease the energy demand and, in turn, to improve the quality of the environment, namely to reduce undesirable emissions of carbon dioxide CO<sub>2</sub> that gives rise to green house effects [8].

In the last decade, ETICS (External Thermal insulation Composite Systems [9]) have been used to remove systemic failures and defects during additional overcladding. This improves energy balance of the panel block buildings and removes heat and moisture defects [10].

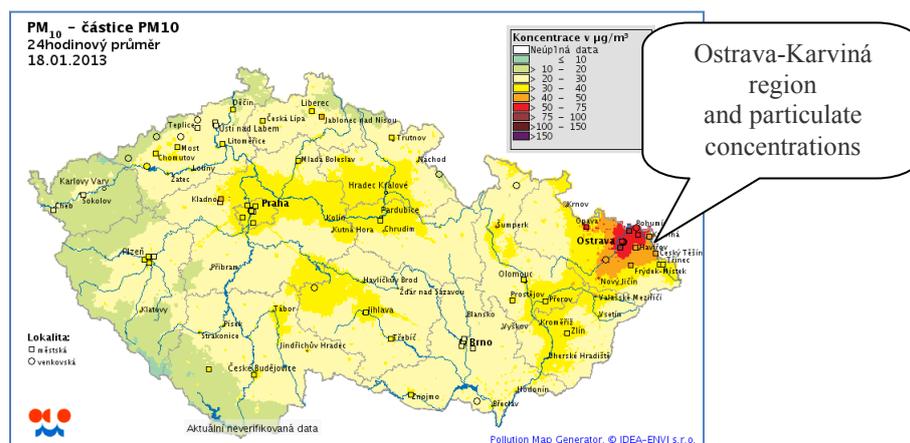
**Fig. 10** Air pollution in the Czech Republic (January 2013)

In spite of the fact that coal mines and some heavy industry plants were shut down in the 1980s and 1990s, air is still being polluted in the Moravia and Silesia (Note: there are four sources of air pollution in the region of Ostrava: industrial plants, local furnaces, transport and air emission from Poland). According to the Health Institute Study, two third of air pollution is caused by sources in Poland during heavily polluted days/smog days. In the Ostrava region, there are more than 2,100 sources of air pollution (400 of them are in Ostrava). Major producers of emission in Ostrava are (in case of all pollutants) big sources – the industry and energy business. In Ostrava, the sources are concentrated in ArcelorMittal's premises in Kuncice (where solid pollutants reach  $425 \text{ g/m}^2$  per year) and in industrial sites in Mariánské Hory-Vitkovice (where solid pollutants reach 51 to  $185 \text{ g/m}^2$ ; [www.dychamproostravu.cz](http://www.dychamproostravu.cz) [13]). (Fig.10) shows the map of pollution in the Czech Republic in January 2013 with 24 hour average values of solid dust particles  $\text{PM}_{10}$  (the  $\text{PM}_{10}$  particles). The figure proves clearly that the concentration of  $\text{PM}_{10}$  particles is rather high in the regions of Ostrava and Karvina. (The air quality index takes into consideration effects of emission on health of people. It uses 1 hour concentration of  $\text{SO}_2$ ,  $\text{NO}_2$ , suspended particles of  $\text{PM}_{10}$ , 8 hour sliding concentration of  $\text{CO}$  and, in summer from 1 April to 30 September, 1 hour concentration of ground ozone  $\text{O}_3$ ) [14].
