# **PRESERVATION OF THE HISTORIC STOCK IN PASSIVE HOUSE REFURBISHMENT**

Martha Enriquez Reinberg, Georg W. Reinberg

A villa from the end of the nineteenth century was renovated in a suburb of Vienna. Both the regal interior rooms (proportions) and the external appearance (heritage protection) were retained. At the same time, heating consumption was reduced to 20 kWh/(m<sup>2</sup>a) through the use of insulation, new windows, airtightness, heat recovery in the ventilation system, and other details. In addition to the renovations, new buildings were constructed, and a joint system of 60 square meters of solar thermal collectors, a biomass-fired heating system, and a central 3500-liter buffer tank covers the remaining heating energy demand.

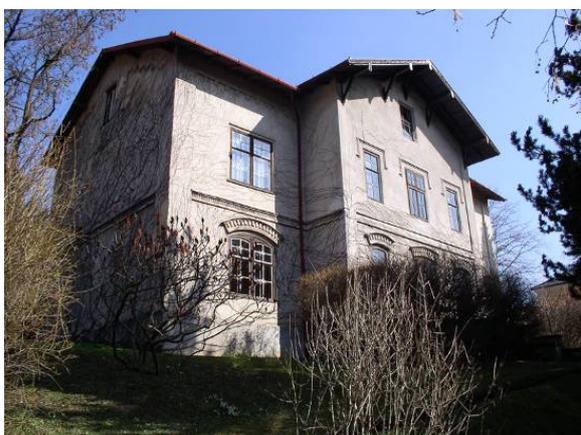
**Fig. 1** before reconstruction

**External insulation:** The relatively simple structure of the prefabricated façade before renovation was documented in detail before most of it was taken down. Twenty-six centimeters of composite insulation was added to the entire façade, which enlarged the building by roughly six percent. An attempt was made to replicate that six percent increase with all components (including roof, building height, etc.) so that the building would retain its overall appearance. The original plaster was re-created, including the color of the lime plaster, to the extent possible.

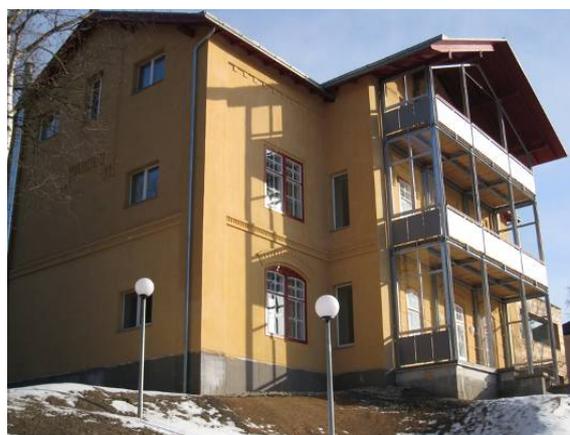
**Fig. 2** after reconstruction

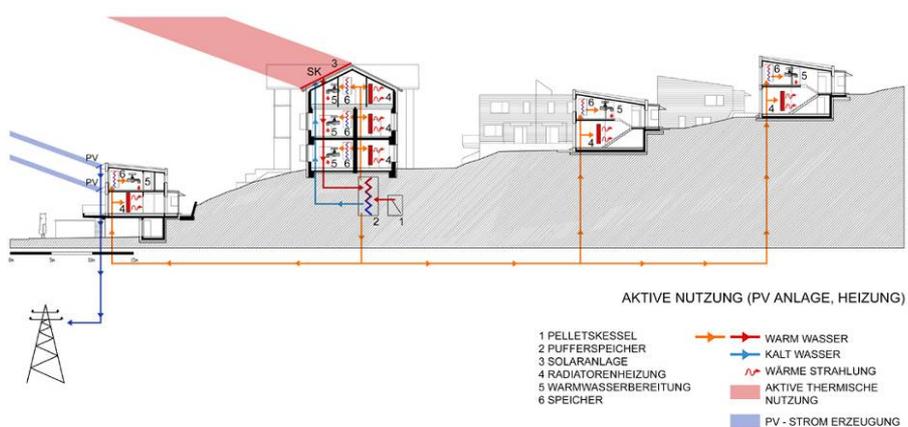
**Fig. 5** Energy concept

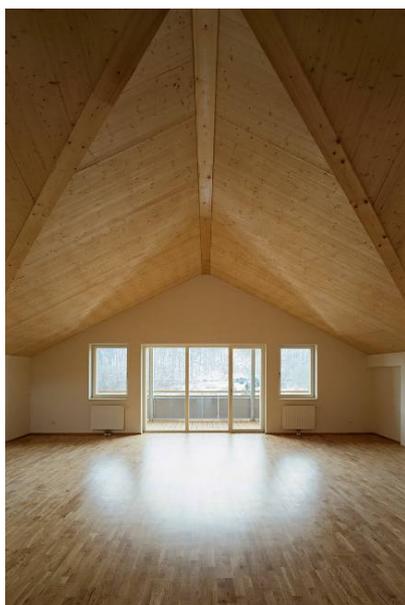
**Fig. 6** Attic

**Attic:** The pitched roof had seen better days and was removed and completely replaced with glued laminated timbers with 30 centimeters of external insulation. The new attic has space for two new apartments.

**Windows in the attic and new windows:** The windows in the old attic had recently been renewed. They were replaced with new, high-quality windows in the same positions ( $uw=0.85$ ). The same technology and positions were used for new windows (to get more light, since the villa was originally only used in the summer and therefore had little daylight).
