THE EVOLUTION OF THE KONYA TRAIN STATION IN HISTORICAL DEVELOPMENT

H. Derya ARSLAN

Necmettin Erbakan University, Architecture Department, Konya, Turkey, deryaarslan@konya.edu.tr

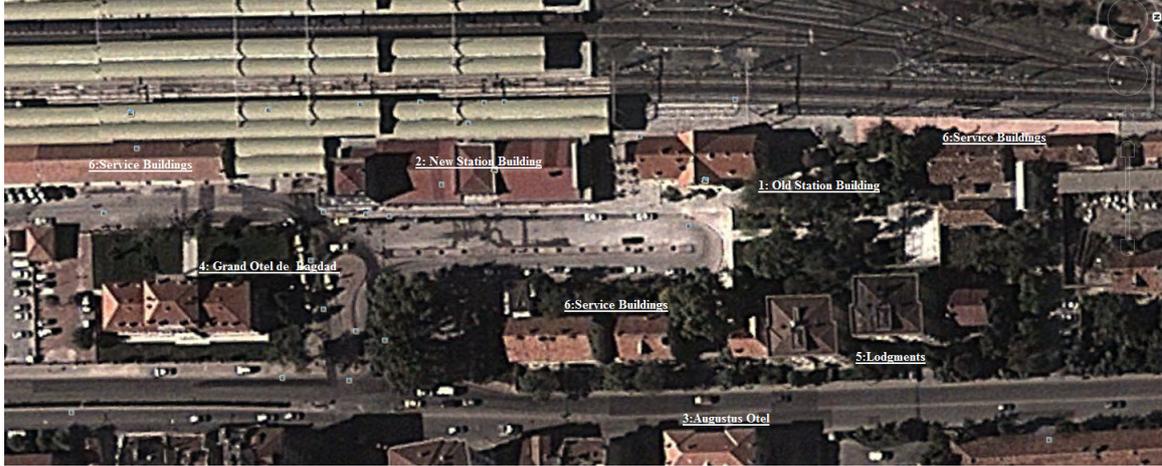
Fig. 1 The settlement plan of the campus

The main station of the line of Bagdad Railway is Konya Station which was constructed by the Germany in 1886 for commercial purposes. Konya was once the capital of Sultanate of Rum and a situation which resulted in much of the architectural heritage visible today. The station of Konya which is the commercial and administrative center of the region looks more like a campus with the station building, lodgments and various buildings reserved for health, security, social and repair-maintenance services situated on an area of about 100.000 m² and have more than 50 buildings. In the *Fig. 1* general plan of the campus is given.

The Konya Train Station building which reflects all the architectural and ornamental characteristics of the German Style has been described and evaluated in detail. All of the buildings in the campus were designed in the German Style which was well accepted and meticulously practiced during that period. The settlement plan of the campus is given in *Fig. 1*.

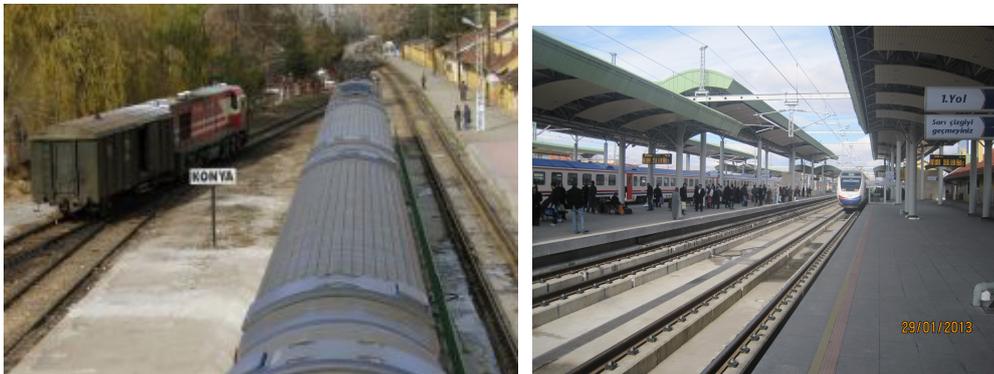
Fig. 2 Old and new station roads

The amount of the passengers has increased and reached ten times a year with starting of the high speed train transportation. Therefore the economical income of the station was increased significantly. In the Figure 2, inner images of the old and new station are given. The all building within the campus have been re-constructed and restored with respect to functional and visual expectation. The general condition of the buildings is going to evaluate in the next stage of the study.

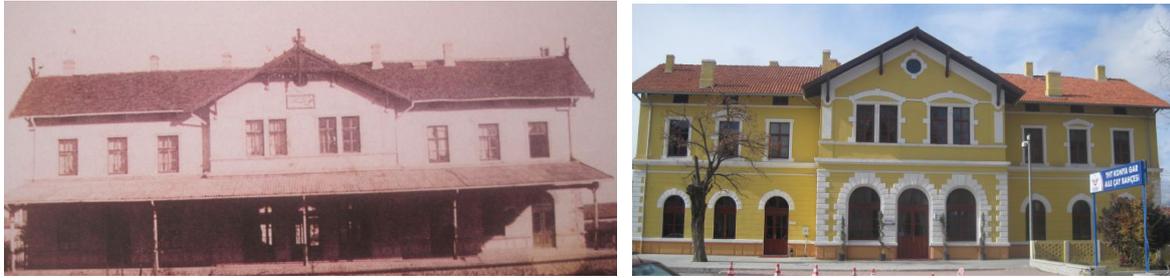
Fig. 3 The old station buildings used as a VIP salon today

The first building within the campus having two stories reflects the whole special feature from its term. The construction of the main station building had finished in 1924. The old building has rehabilitated and been used as a VIP salon and administration, recently. In the **Fig. 3** and **Fig. 4**, the old and new main station buildings are given, respectively.

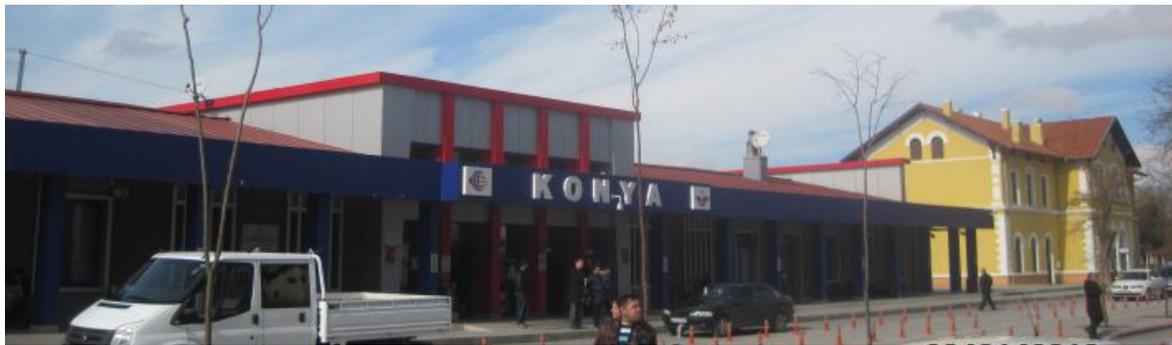
Fig. 4 The new and old station buildings

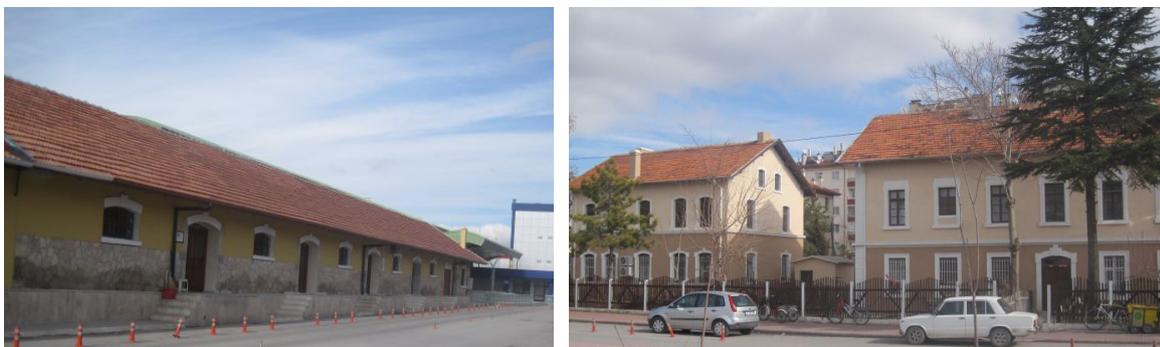
Fig. 5 Service buildings

There are a lot of service buildings of whose the usage aim permanently change and finally used with the different duties. **Fig. 5** shows the example of these buildings.

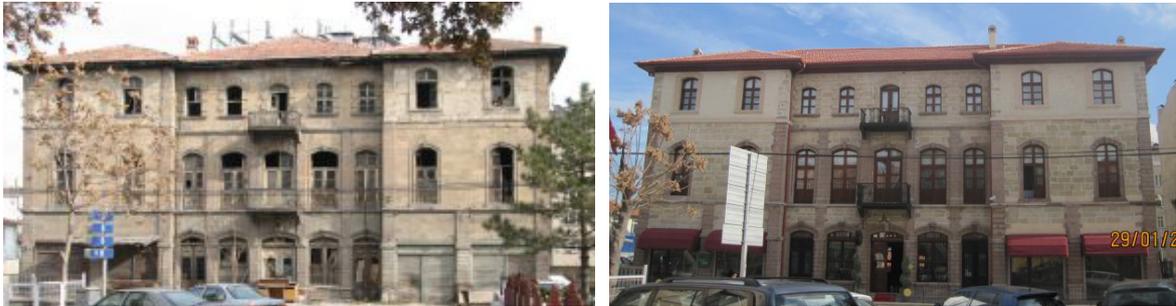
Fig. 6 *The Augustus Hotel*

The Augustus Hotel situated to the western of the Konya Station, constructed with the reaching of the line to the Konya Station in 1895. After 1924 the hotel building have used

as military transportation school awhile and post office for a while. After this process the building was again hotel building. The stone workmanship of the facade, the baroc architecture belt in windows, key stone on arc, wrought iron shows the 19th century Europe Architecture style. The building which was leaved in 1980 has been rehabilitated and opened to service with the rapid train increasing passenger number (**Fig. 6**).

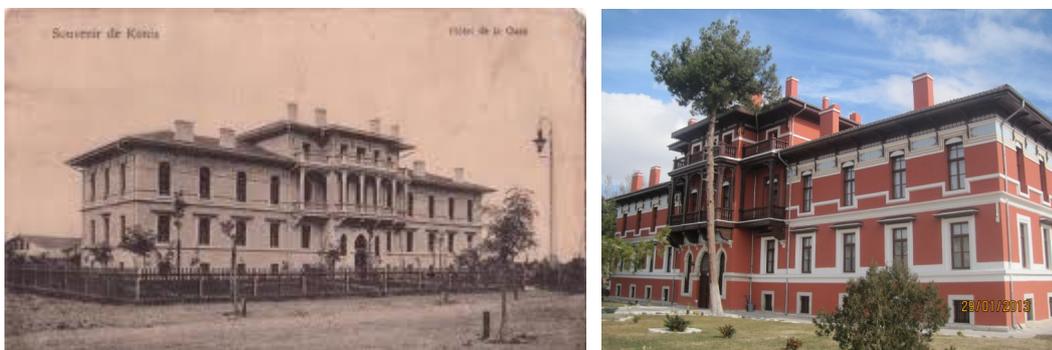
Fig. 7 *Grand Hotel de Bagdad*

Grand Hotel de Bagdad has been constructed in 1912 after the opening of Konya railway station for the passenger who is traveling with train. It was been used as headquarters meeting point in 1920. After the declaration of Republic the building has came more importer and it has got higher by adding flat near two wings. There has organized various conferences in the reading room which is at the subterranean of the Hotel building. After the years this building has serviced various different function and it uses as a guesthouse today (**Fig. 7**).

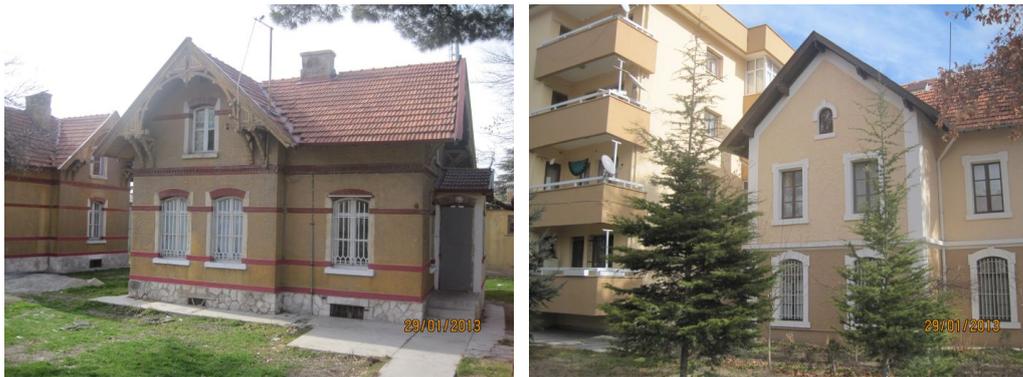
Fig. 8 Lodgments

There is a lot of lodgment building in the railway campus. Some part of lodgment has been emptied in the course of time and has used for various service function. Another part of these lodgment has been emptied today for using them as social activity spaces and its planed to service at near future. As addition to the lodgment building which haves Germany architecture style there is two reinforced lodgment building having four stories. However lack of harmony between historical station buildings and these new lodgment buildings to be seen in Figure 8 are thinking to be demolished in near future (**Fig.8**).
